**Flood Control Project Maintenance  
Levee Inspections**

**Fall 2013 Levee Maintenance Deficiency Summary Report**

**Reclamation District No. 2095 Paradise Cut**

**Levee Inspection Report By Mile - Fall 2013**

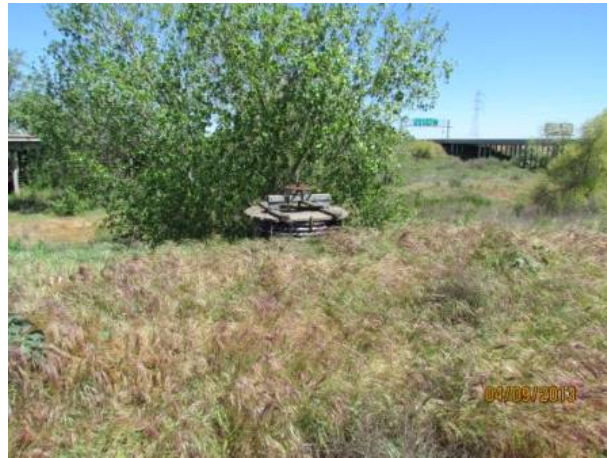
Levee Mile Report Line	4
Start Levee Mile	0.07
End Levee Mile	0.07
Location	Water Side
Category	Earthen Levee
Item	Encroachments

View of the pipe at waterside levee hinge.

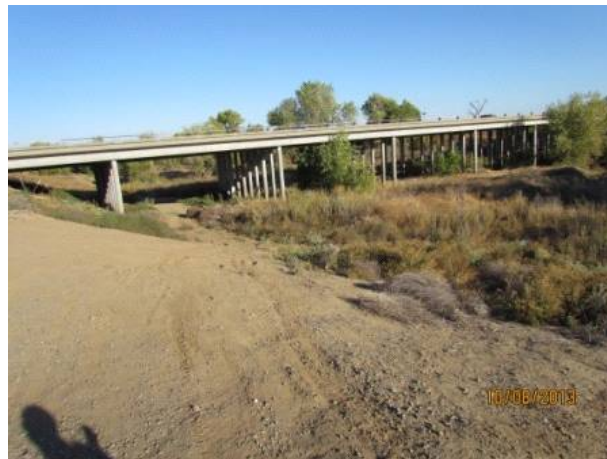
Levee Mile Report Line	5
Start Levee Mile	0.15
End Levee Mile	0.15
Location	Water Side
Category	Earthen Levee
Item	Slope Stability

View of vehicle ruts eroding waterside slope.

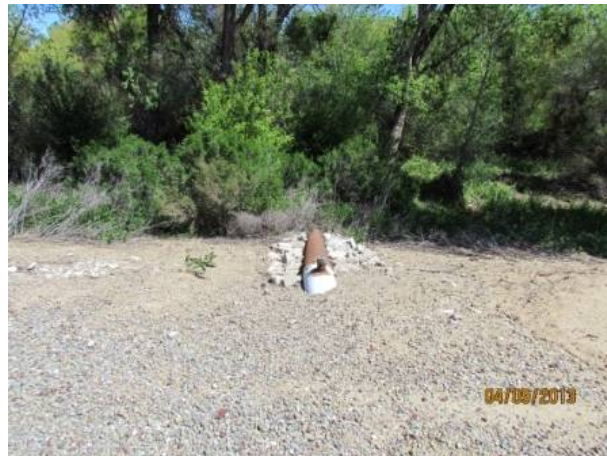
Levee Mile Report Line	8
Start Levee Mile	0.35
End Levee Mile	0.35
Location	Crown
Category	Earthen Levee
Item	Encroachments

View of the pipe penetrating waterside levee slope.

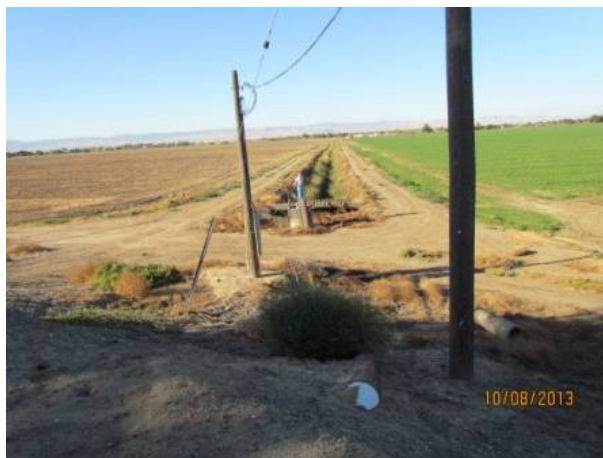
Levee Mile Report Line	8
Start Levee Mile	0.35
End Levee Mile	0.35
Location	Crown
Category	Earthen Levee
Item	Encroachments

View of pipe day lighting at landside levee slope.

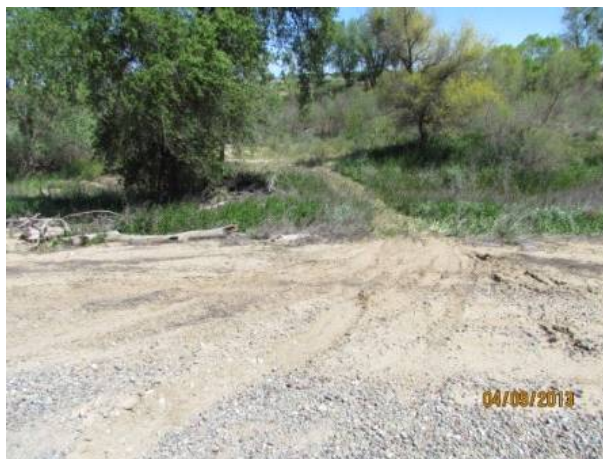
Levee Mile Report Line	9
Start Levee Mile	0.42
End Levee Mile	0.42
Location	Water Side
Category	Earthen Levee
Item	Slope Stability

View of the vehicle ruts on waterside levee slope.

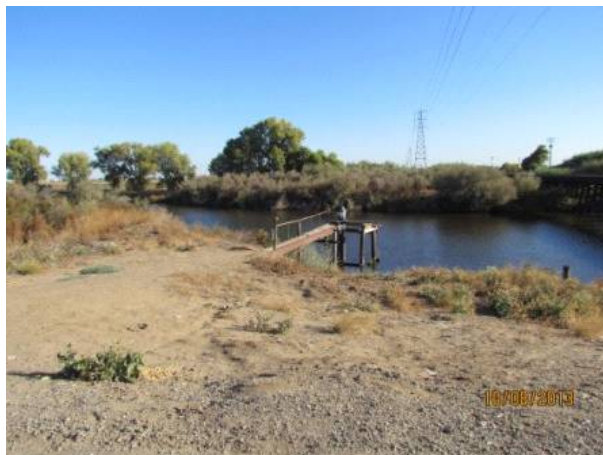
Levee Mile Report Line	10
Start Levee Mile	0.70
End Levee Mile	0.70
Location	Water Side
Category	Earthen Levee
Item	Encroachments

View of pipe and pump motor on the waterside.

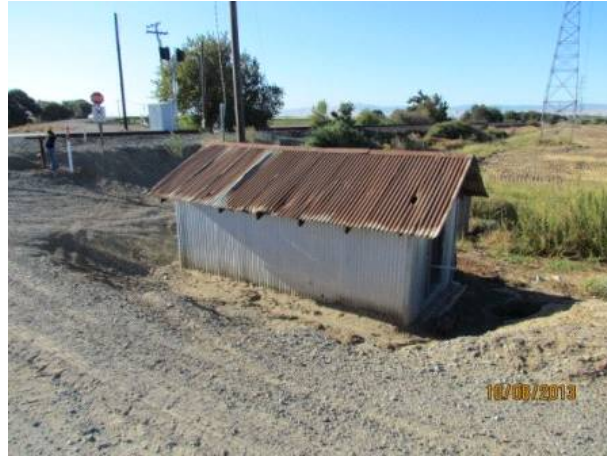
Levee Mile Report Line	11
Start Levee Mile	0.70
End Levee Mile	0.70
Location	Land Side
Category	Earthen Levee
Item	Encroachments

DWR ID: DWR_RD2095_01_s_2012_10									
11	0.70	0.70	Earthen Levee	Encroachments	LS M En	BU : Building Inspector Comments: Pump house near RR.	37.763630 ° -121.319045 °	37.763630 ° -121.319045 °	11 Y
DWR ID: DWR_RD2095_01_s_2012_11

View of building at the landside levee toe.

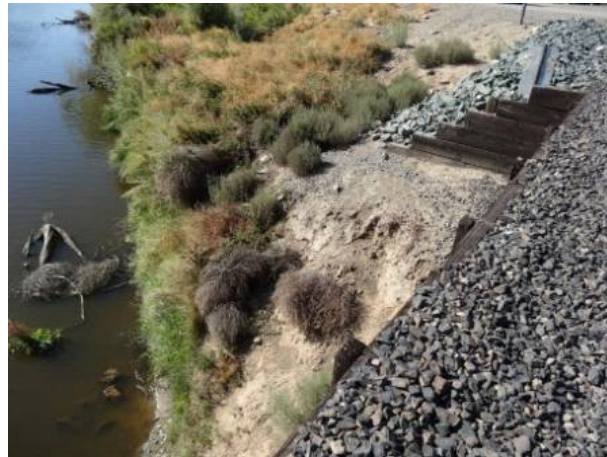
Levee Mile Report Line	12
Start Levee Mile	0.73
End Levee Mile	0.74
Location	Water Side
Category	Supplemental
Item	DWR Erosion Survey

Direct view of the erosion at the upstream of RR bridge.

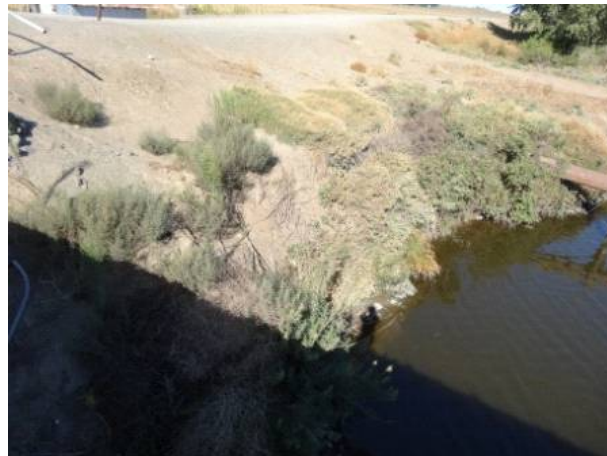
Levee Mile Report Line	12
Start Levee Mile	0.73
End Levee Mile	0.74
Location	Water Side
Category	Supplemental
Item	DWR Erosion Survey

Close view of the erosion downstream RR bridge.

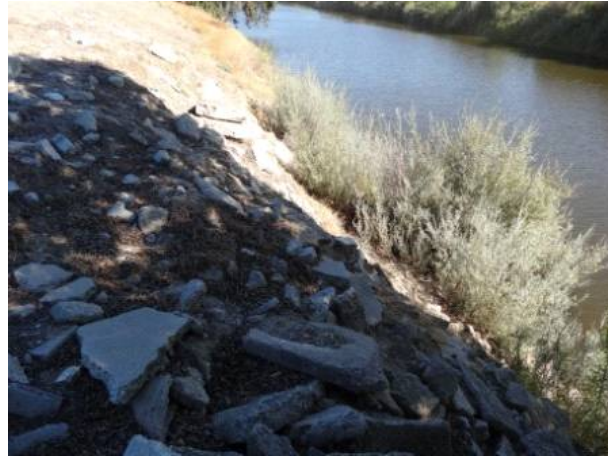
Levee Mile Report Line	13
Start Levee Mile	0.86
End Levee Mile	0.86
Location	Water Side
Category	Supplemental
Item	DWR Erosion Survey

Direct view of the site.

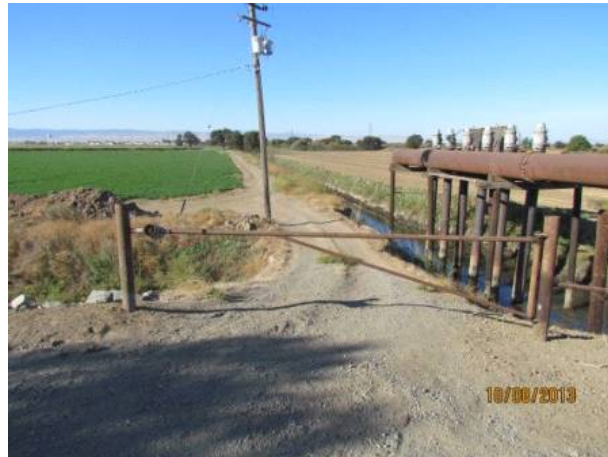
Levee Mile Report Line	14
Start Levee Mile	0.87
End Levee Mile	0.87
Location	Land Side
Category	Earthen Levee
Item	Encroachments

View of the new gate at landside levee hinge.

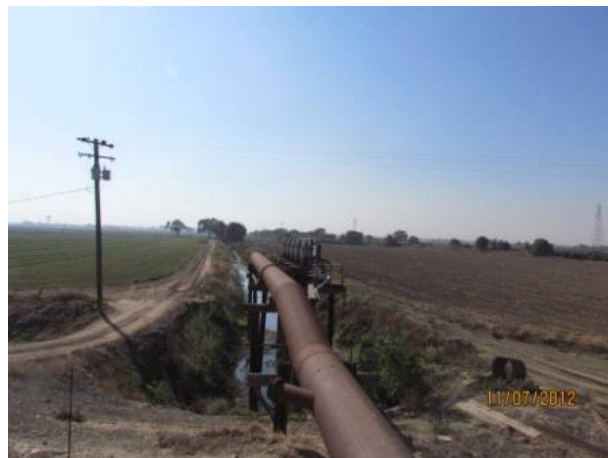
Levee Mile Report Line	15
Start Levee Mile	0.87
End Levee Mile	0.87
Location	Land Side
Category	Earthen Levee
Item	Encroachments

View of the pumps on landside.

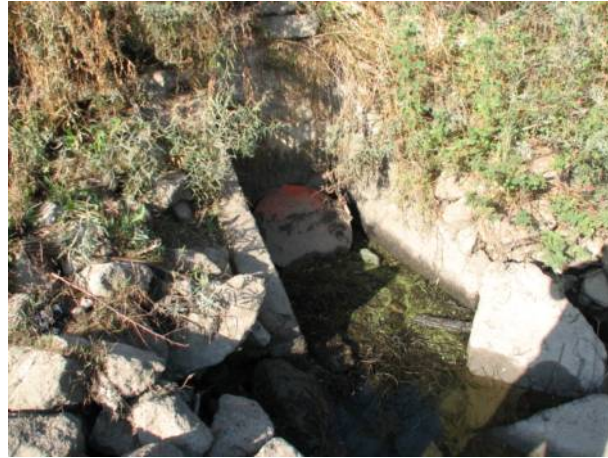
Levee Mile Report Line	16
Start Levee Mile	0.88
End Levee Mile	0.88
Location	Water Side
Category	Earthen Levee
Item	Encroachments

Gravity drainage outlet flapgate blocked by debris.

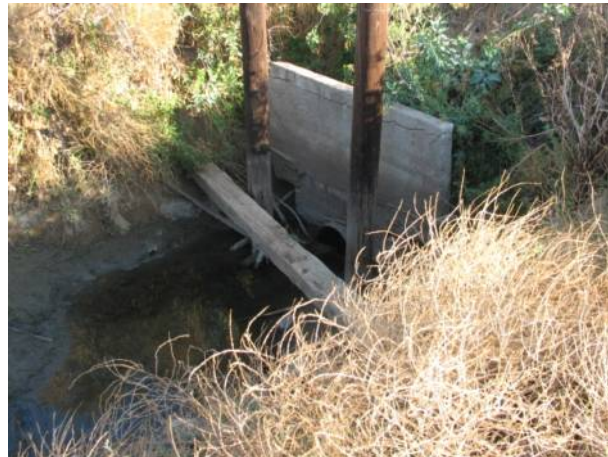
Levee Mile Report Line	16
Start Levee Mile	0.88
End Levee Mile	0.88
Location	Water Side
Category	Earthen Levee
Item	Encroachments

Gravity drain inlet.

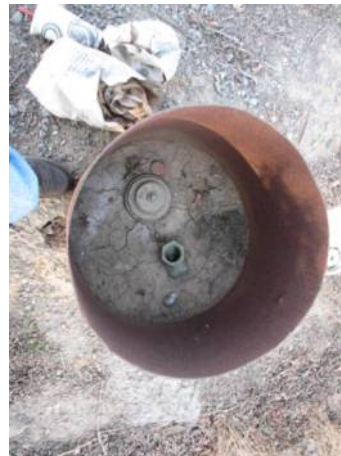
Levee Mile Report Line	17
Start Levee Mile	0.92
End Levee Mile	0.92
Location	Land Side
Category	Earthen Levee
Item	Encroachments

11/01/2011 Siphon breaker at hinge point on waterside.

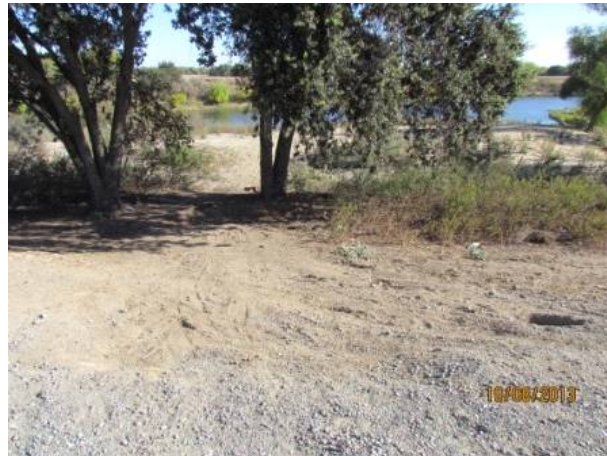
Levee Mile Report Line	1
Start Levee Mile	0.03
End Levee Mile	0.03
Location	Water Side
Category	Earthen Levee
Item	Slope Stability

View of the vehicle tire ruts on waterside levee slope.

LMR No.	Levee Mile		Category	Item	Location	Rating	Action/Comment	GPS Latitude/Longitude		Issue No.
	Start	End						Start	End	
1	0.03	0.03	Earthen Levee	Slope Stability	WS	M	S3 : Repair the levee slope damaged by vehicle traffic and prevent access where possible.	37.758986 ° -121.307854 °	37.758986 ° -121.307854 °	9 Y
DWR ID: DWR_RD2095_02_s_2013_9										
2	0.18	0.18	Earthen Levee	Slope Stability	WS	M	S3 : Repair the levee slope damaged by vehicle traffic and prevent access where possible.	37.757322 ° -121.306291 °	37.757322 ° -121.306291 °	10 Y
DWR ID: DWR_RD2095_02_s_2013_10										
3	0.36	0.85	Earthen Levee	Encroachments	LS	M	DT : Ditch	37.754952 ° -121.305880 °	37.749645 ° -121.301977 °	5 Y
DWR ID: DWR_RD2095_02_f_2012_5										
4	0.44	0.77	Earthen Levee	Crown Surface / Depressions / Rutting	CR	C	C2 : Repair depressions or ruts in the crown or slope.	37.753980 ° -121.305600 °	37.749613 ° -121.302967 °	7

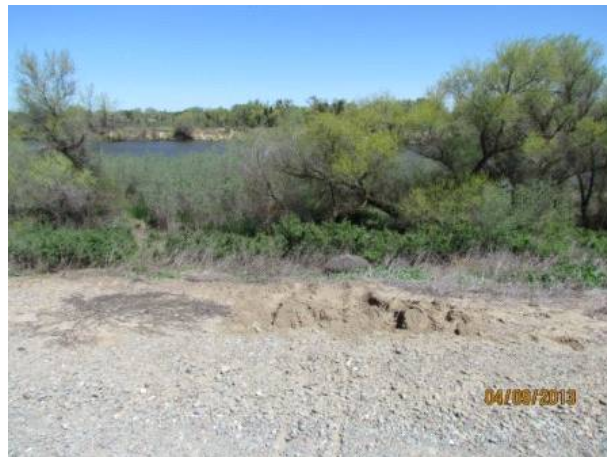
Levee Mile Report Line	2
Start Levee Mile	0.18
End Levee Mile	0.18
Location	Water Side
Category	Earthen Levee
Item	Slope Stability

View of the vehicle tire ruts on waterside levee slope.

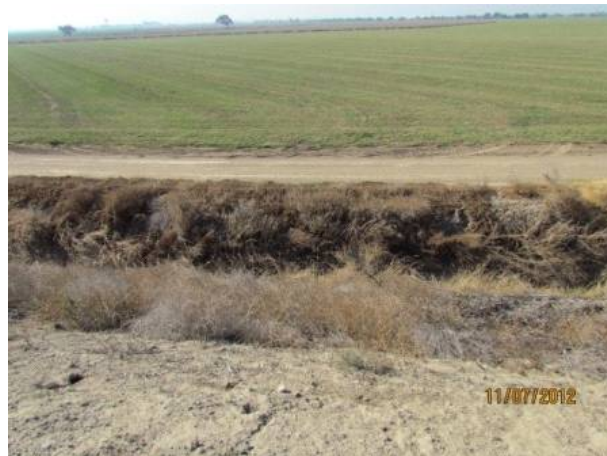
Levee Mile Report Line	3
Start Levee Mile	0.36
End Levee Mile	0.85
Location	Land Side
Category	Earthen Levee
Item	Encroachments

View of ditch along landside toe.

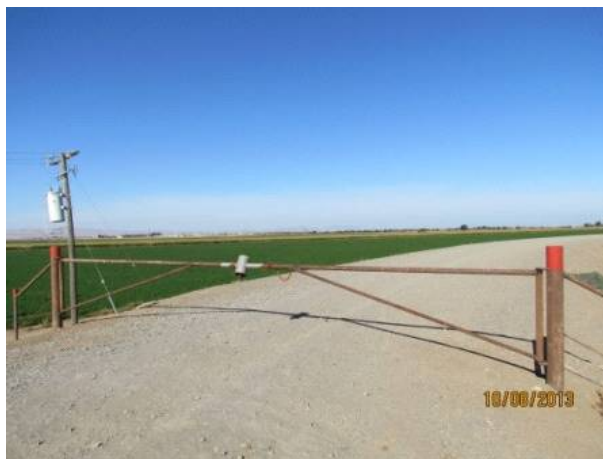
Levee Mile Report Line	6
Start Levee Mile	0.75
End Levee Mile	0.75
Location	Crown
Category	Earthen Levee
Item	Encroachments

View of new gate across levee crown.

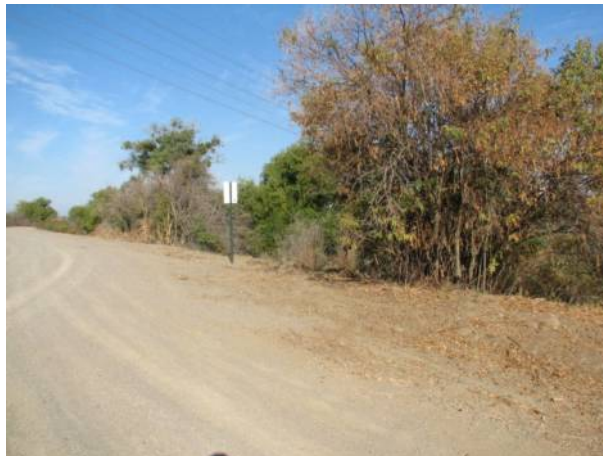
Levee Mile Report Line	10
Start Levee Mile	1.01
End Levee Mile	1.01
Location	Water Side
Category	Earthen Levee
Item	Vegetation

Elderberry blocks visibility of levee slope.

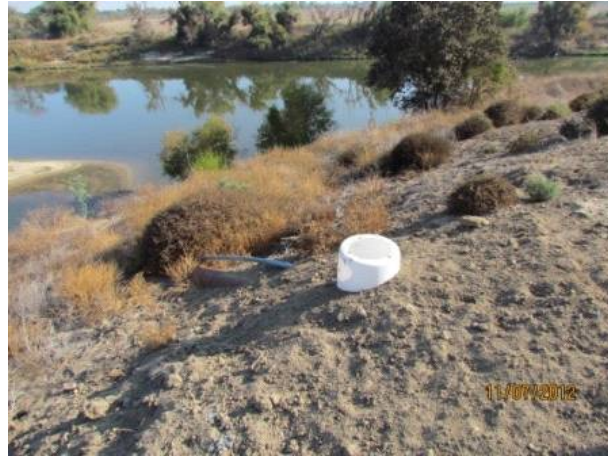
Levee Mile Report Line	14
Start Levee Mile	1.65
End Levee Mile	1.65
Location	Crown
Category	Earthen Levee
Item	Encroachments

14	1.65	1.65	Earthen Levee	Encroachments	CR A/W	PI : Pipe	Inspector Comments: Discharge pipe into San Joaquin River. Anti-siphon valve present. Pipe penetrates levee freeboard. Fill and compact erosion site.	37.741340 ° -121.296158 °	37.741340 ° -121.296158 °	15 Y
----	------	------	---------------	---------------	--------	-----------	---	------------------------------	------------------------------	---------

View of corrected slope erosion. Siphon breaker valve is covered by bucket with drain pipe diverting water away from slope.

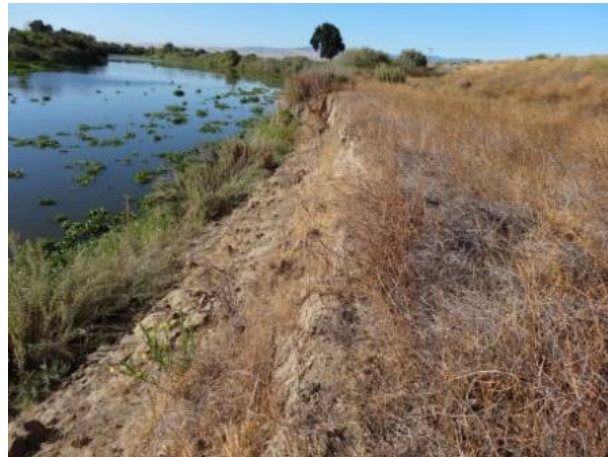
Levee Mile Report Line	15
Start Levee Mile	1.77
End Levee Mile	1.80
Location	Water Side
Category	Supplemental
Item	DWR Erosion Survey

15	1.77	1.80	Supplemental	DWR Erosion Survey	WS	M	Inspector Comments: 08/28/2013: No significant change observed. 09/13/2012: The site has been visited by land survey. The vegetation on the site shows the erosion has not developed significantly from the last survey. The site was not visited by boat survey due to the limitation of navigable waterway. 08/23/2011: No significant changes observed. 9/22/2010: No significant changes observed. There is moderate vegetation growth on the berm. Despite the erosion occurring on the berm, corrective action should be taken before the issue becomes severe. 9/29/2009: Site is immediately downstream of a section of existing rip rap; there is a 20-foot berm remaining; berm will continue to erode unless erosion is mitigated; Site# is the same as RM62.6, LM1.87; recommended for annual assessment, per CES Evaluation 2008 Report 2006: Visited 10/20/06 [2013 Site ID:RD2095U02RM60.62]	37.740196 ° -121.297662 °	37.740196 ° -121.297662 °	1 Y

Looking at the erosion.

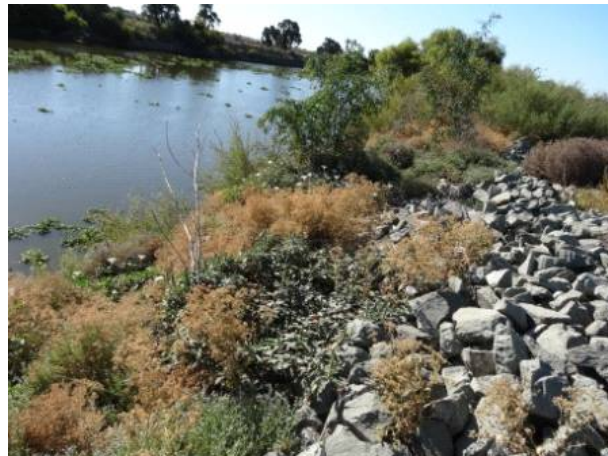
Levee Mile Report Line	16
Start Levee Mile	1.85
End Levee Mile	1.89
Location	Water Side
Category	Supplemental
Item	DWR Erosion Survey

16	1.85	1.89	Supplemental	DWR Erosion Survey	WS	M	Inspector Comments: 08/28/2013: No significant change observed. Dense vegetation blocks the visual inspection at the site. 09/13/2012: The site has been visited by land survey. The erosion is not visible from the levee slope because of dense vegetation at the site. Levee slope is protected by placed rocks. The site was not visited by boat survey due to the limitation of navigable waterway. 08/23/2011: Dense vegetation makes it difficult to view the possible erosion. No new development was observed on site. 09/23/2010: At the time of the inspection, the erosion site was difficult to view from the levee. Erosion is located on the bank toe, below the existing rip rap. There were no signs of repair on site, nor has the site been reported to be repaired by the district. Images taken from last year indicate that existing rip rap at the bank toe has sloughed exposing the underlying soils. Weakening of the toe could lead to future bank instability. 08/05/2010: Recommended for annual assessment and monitoring during flood events, per CLRO. 09/29/2009: No major change observed since last visit; sloughing of the rip rap above toe; erosion begins immediately downstream of existing rip rap revetment; roughly 15-foot berm remains; however, it will continue to erode and eventually intrude into the levee profile if left untreated. 10/20/2006: Just upstream of where berm starts to widen. [2013 Site ID:RD2095U02RM60.69]	37.738880 ° -121.298260 °	37.738880 ° -121.298260 °	2 Y

Direct view of the erosion.

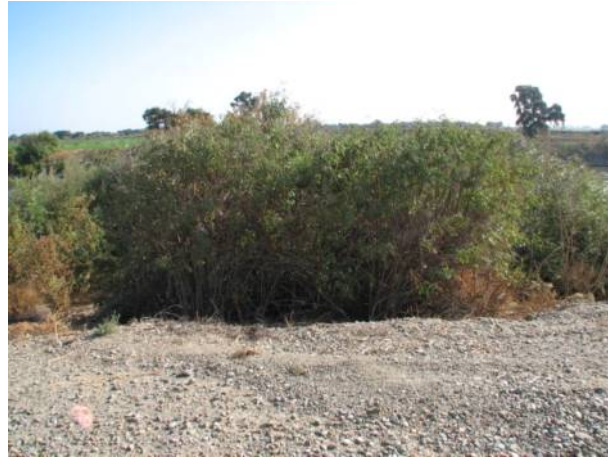
Levee Mile Report Line	18
Start Levee Mile	2.14
End Levee Mile	2.14
Location	Water Side
Category	Earthen Levee
Item	Vegetation

Vegetation on waterside slope obstructs access and visibility.
